Graze site with cattle.  
Remove litter from site.  
Check for and pull himalayan balsam along the length of the river

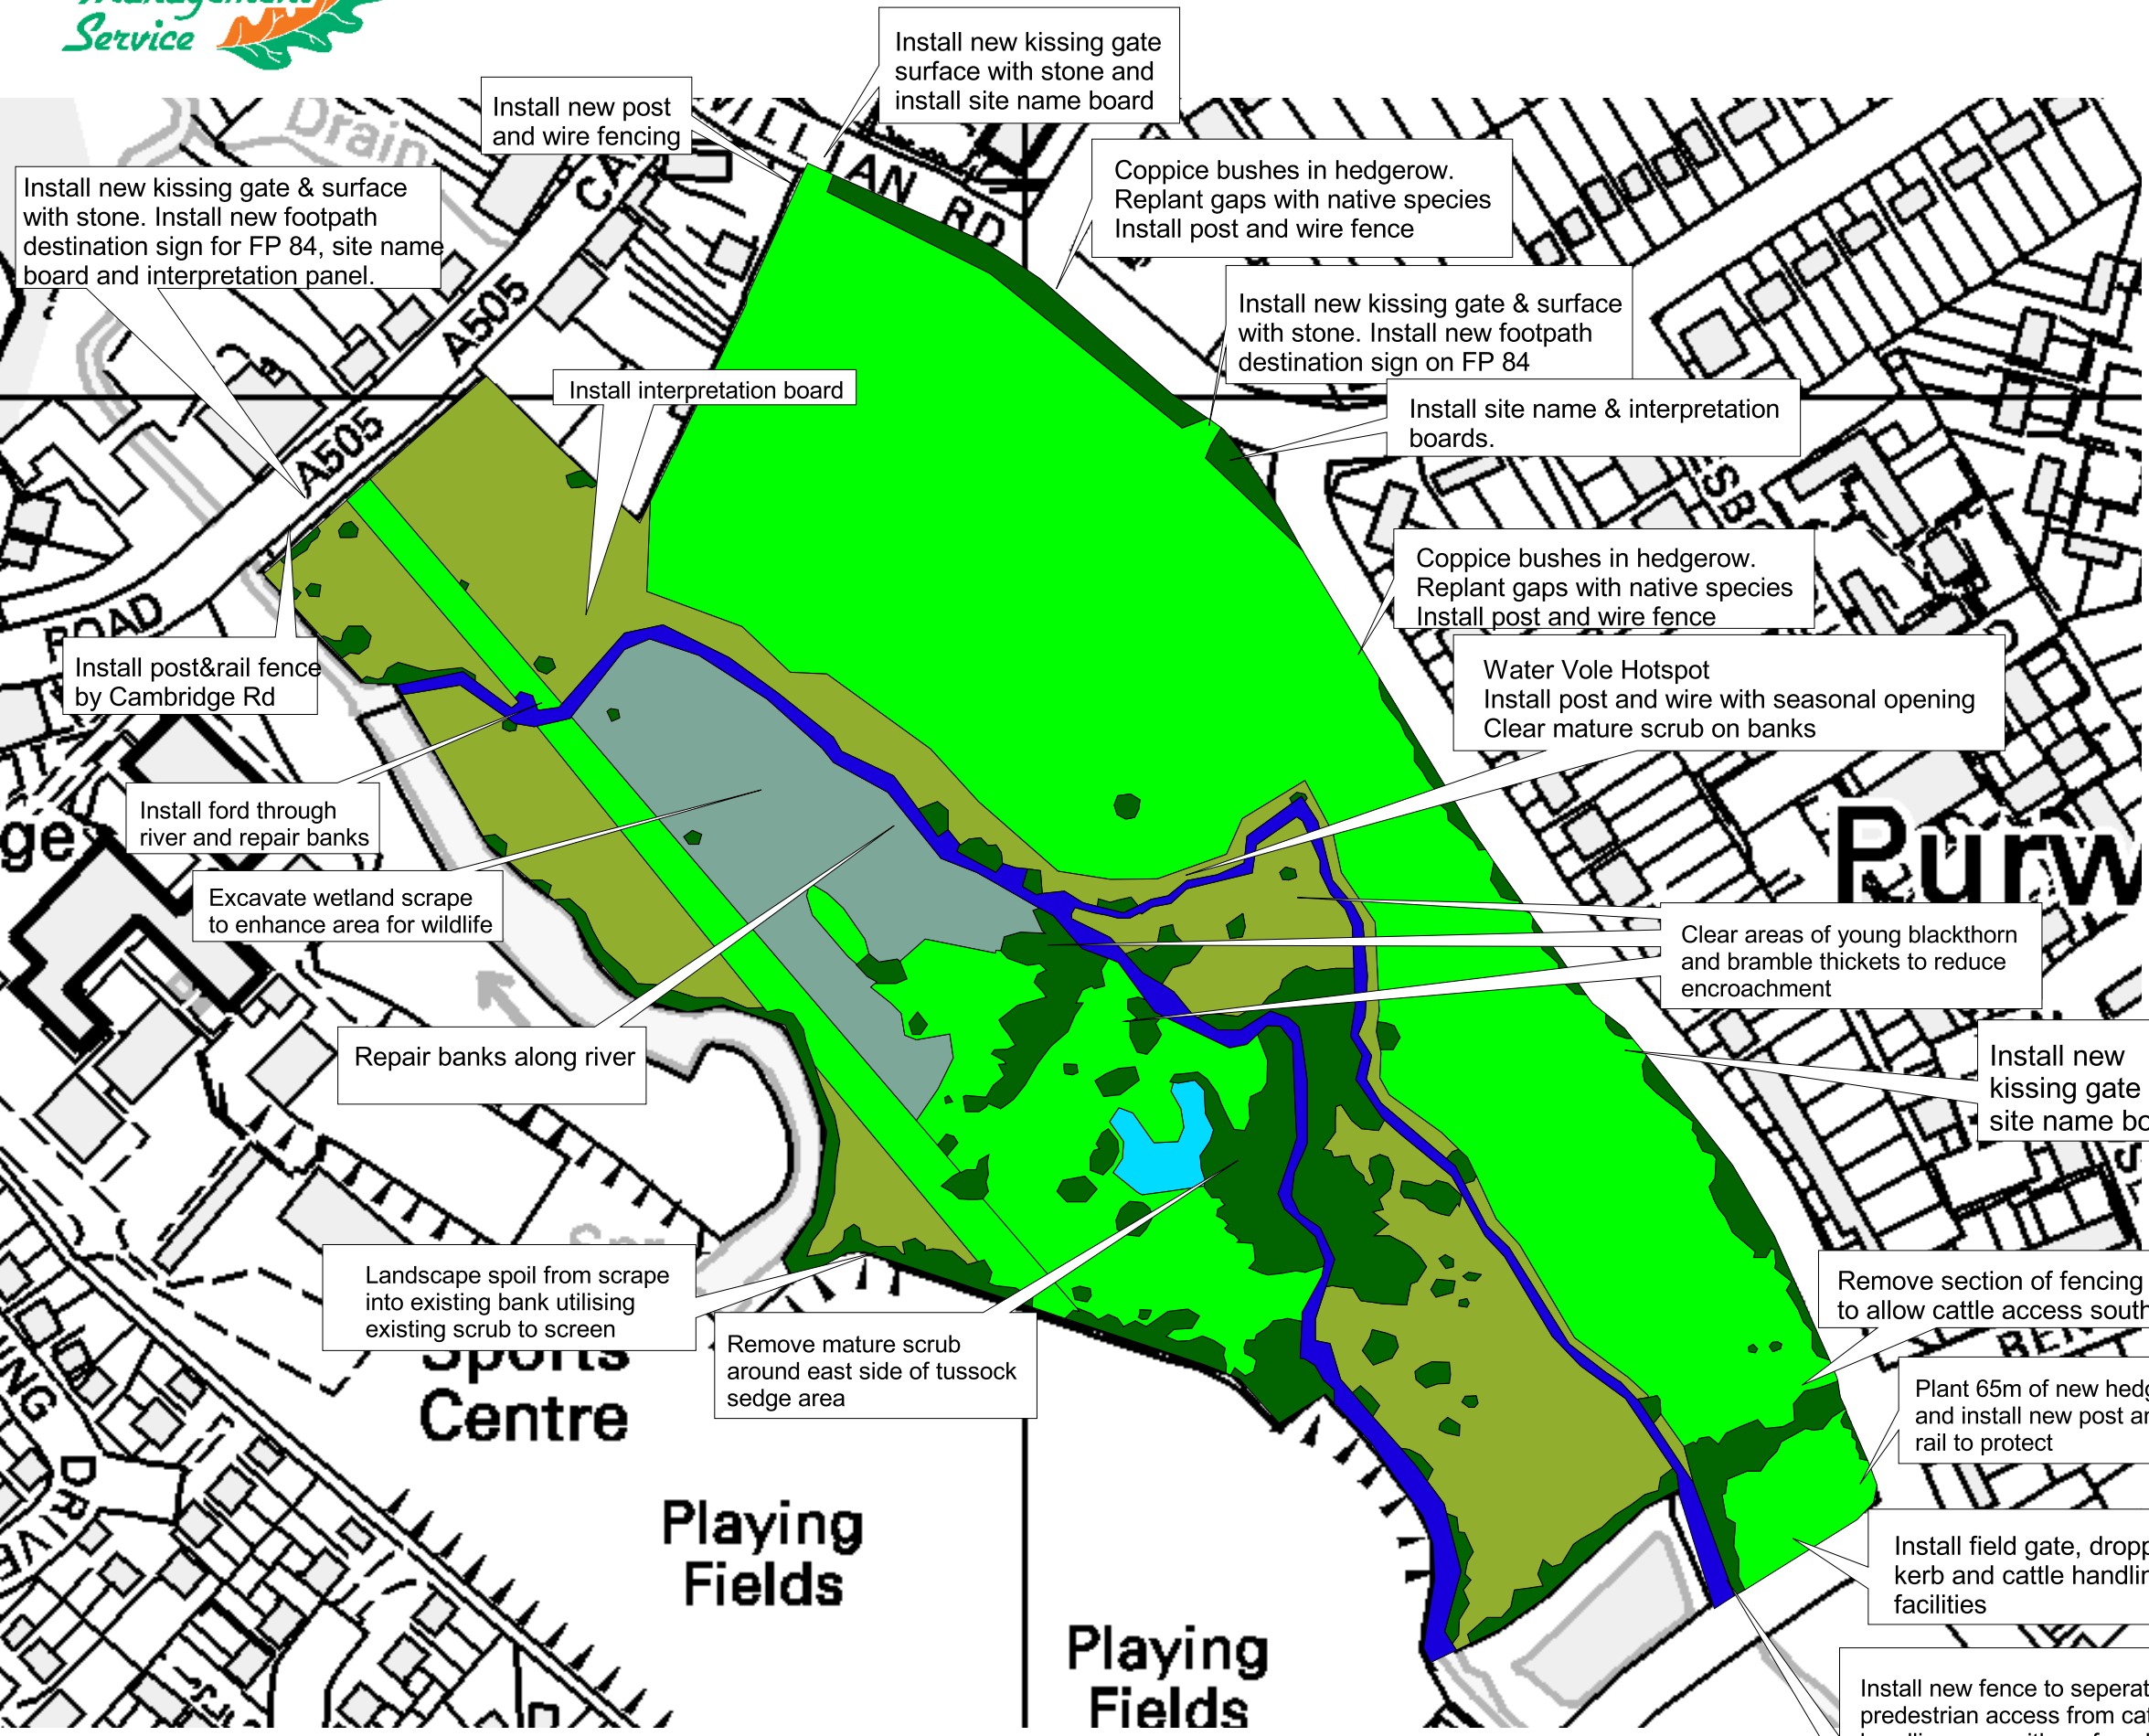
**1:2000**

Install new kissing gate & surface with stone. Install new footpath destination sign for FP 84, site name board and interpretation panel.

Install new post and wire fencing

Install new kissing gate surface with stone and install site name board

Coppice bushes in hedgerow. Replant gaps with native species. Install post and wire fence

Install new kissing gate & surface with stone. Install new footpath destination sign on FP 84

Install site name & interpretation boards.

Water Vole Hotspot. Install post and wire with seasonal opening. Clear mature scrub on banks

Clear areas of young blackthorn and bramble thickets to reduce encroachment

Install new kissing gate and site name board

Remove section of fencing to allow cattle access south

Plant 65m of new hedge and install new post and rail to protect

Install field gate, dropped kerb and cattle handling facilities

Install new fence to separate pedestrian access from cattle handling area with surfaced kissing gate, site name and interpretation boards at entrance

Install post & rail fence by Cambridge Rd

Install ford through river and repair banks

Excavate wetland scrape to enhance area for wildlife

Repair banks along river

Landscape spoil from scrape into existing bank utilising existing scrub to screen

Remove mature scrub around east side of tussock sedge area
